Advanced in Pulsed Thermography for NDT

Dr. Steven M. Shepard
Thermal Wave Imaging, Inc.
845 Livernois
Ferndale, MI 48220

Basic Technology: Flash Thermography

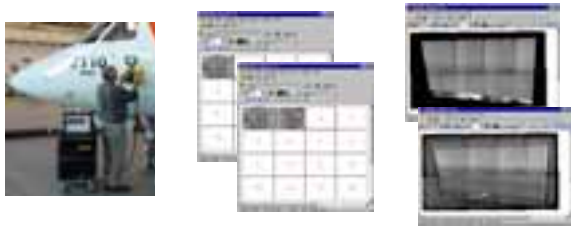
Thermographic Signal Reconstruction (TSR)

Inspect the part using EchoTherm or ThermoScape. → A MOSAIQ image of the part is built dynamically as the data is acquired. → Use advanced TSR processing to see hidden subsurface detail.
